4. TITLE (and Subtitie)	TYPE OF REPORT & PERIOD COVER
DATA COLLECTION AND ANALYSIS, RUNWAY 4R-22L,	Final repet,
O'HARÉ INTERNATIONAL AIRPORT	6. PERFORMING ORG. REPORT NUMBE
32 5	G. PERFORMING ORG. REPORT NUMBE.

7. AUTHOR(a)	8. CONTRACT OR GRANT NUMBER(a)
Harvey J. Treybig, Harold L. Von Quintus and	
B. Frank/McCullough	Contract DACW39-75-C-00
	(15)
9. PERFORMING ORGANIZATION NAME AND ADDRESS	10. PROGRAM ELEMENT, PROJECT, TA
Austin Research Engineers, Inc.	AND A ST
Engineering Consultants	(12)11 04P: /
5706 Bee Cave Road, Austin, Texas 78746

11. CONTROLLING OFFICE NAME AND ADDRESS	12. REPORT DATE
Federal Aviation Administration Systems Research and Development Service	Sept. 1976
Washington, D. C. 20591	NUMBER OF PAGES
MONITORING AGENCY NAME & ADDRESS(If different from Controlling Office)	i

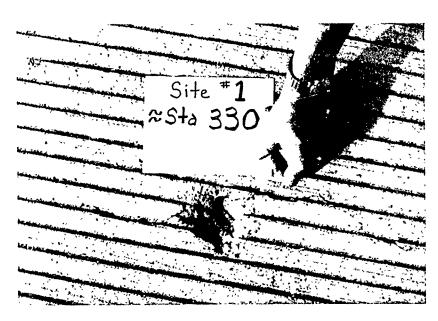
Figure 25. Close-up of an aggregate popout with some distress developing around popout.

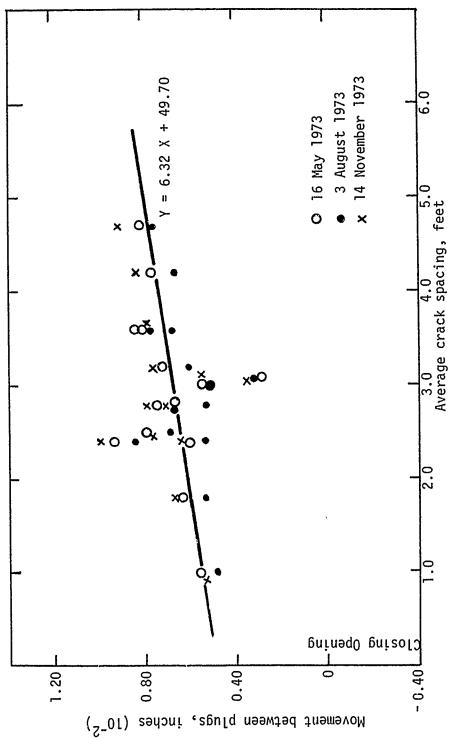
Figure 26. Crack width measurements taken with the Whitmore Strain gage at Station 306 + 50 (Interior lane) expressed as a function of crack spacing.

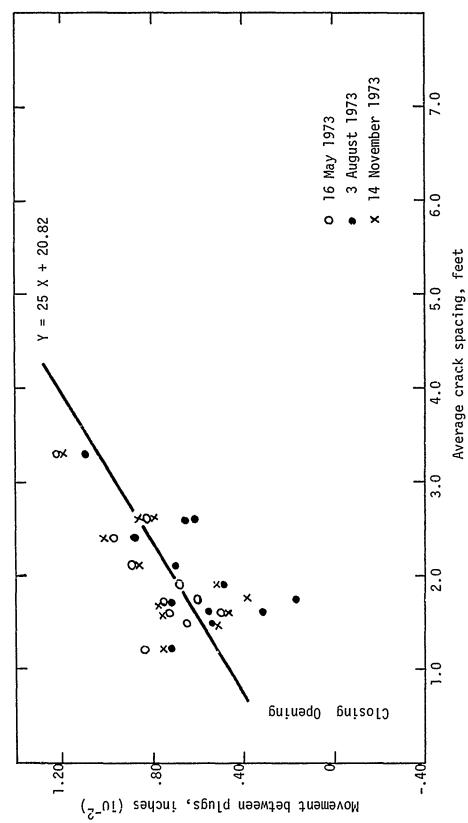
Figure 27. Crack width measurements taken with the Whitmore Strain gage at Station 305 + 50 (outer lane) expressed as a function of crack spacing.

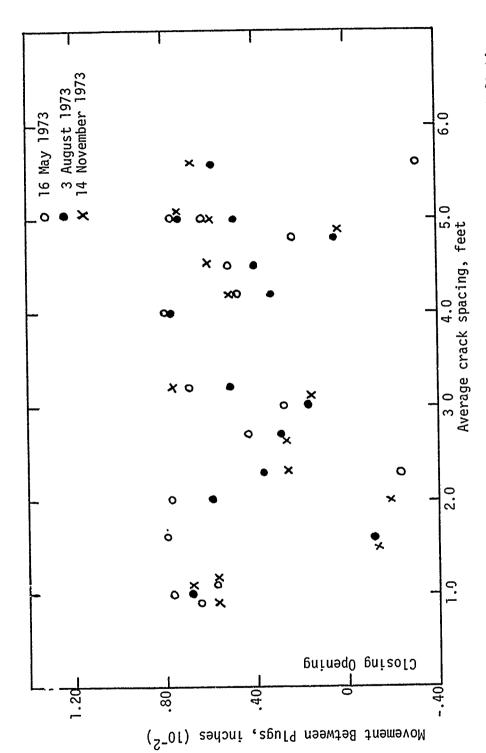
Crack width measurements taken with the Whitmore Strain gage at Station 304 + 60 (outer lane) expressed as a function of crack spacing. Figure 28.

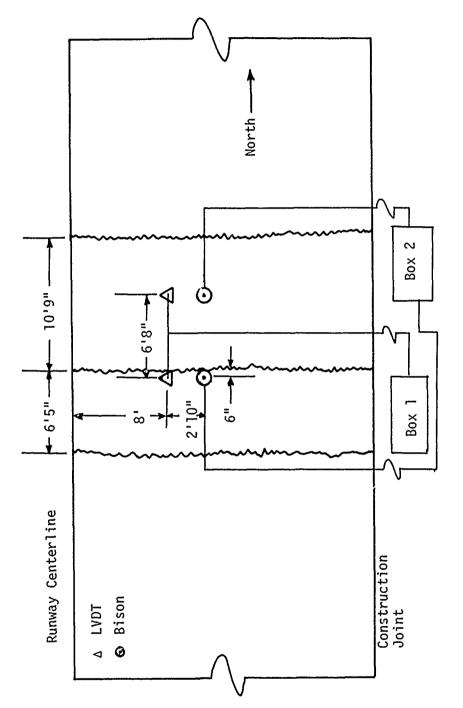
Figure Al. Site 1 Station 328 + 48, End of runway in wheel path of B727, either interior paving lane.

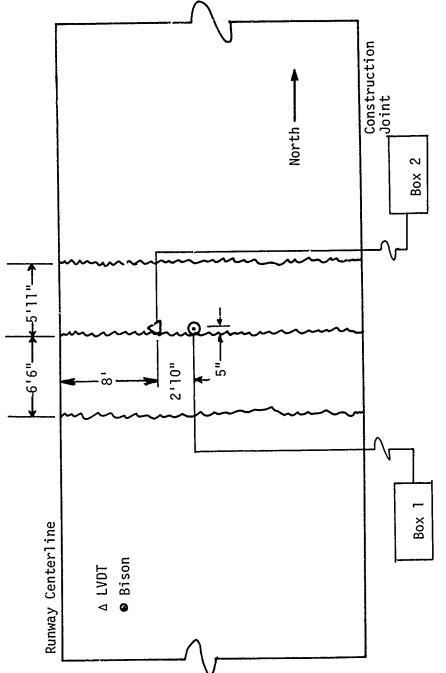
Site 2 Station 320 + 88, Touchdown area, in wheel path of B727, either interior paving lane. Figure A2.

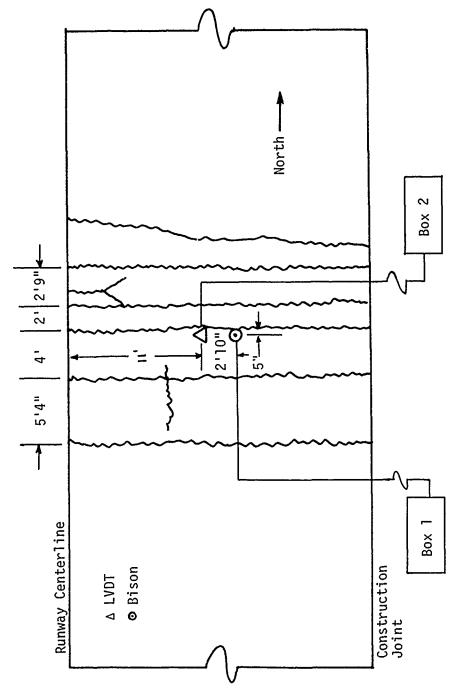
Figure A3. Site 3 Station 305 + 66, Rotation area in wheel path of B727, either interior paving lane.

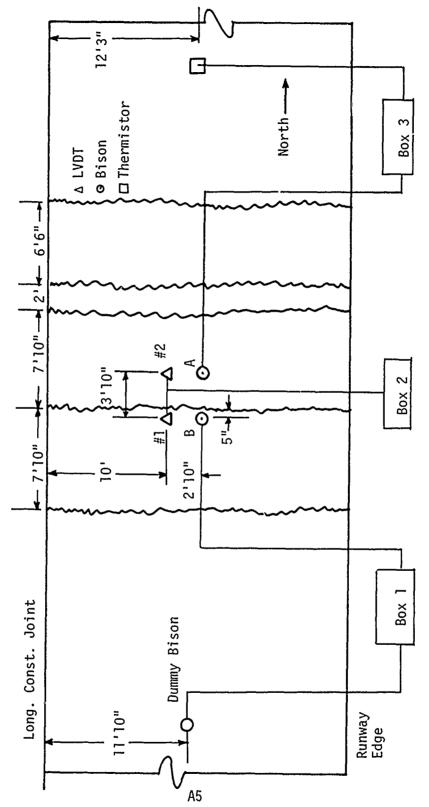
Figure A4. Site 4 - Station 305 + 77, No traffic, outer paving lane, (adjacent to site 3).

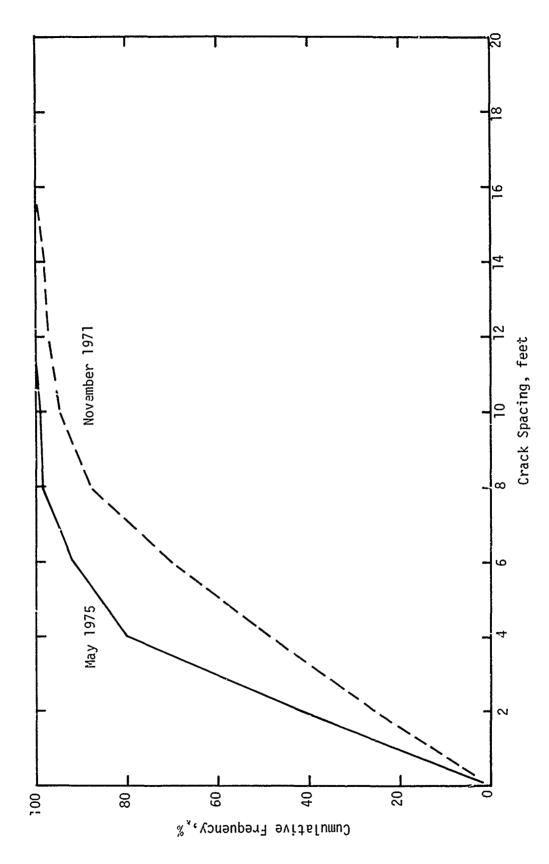
Figure B3. Distribution of crack spacing for two time periods at Section C.

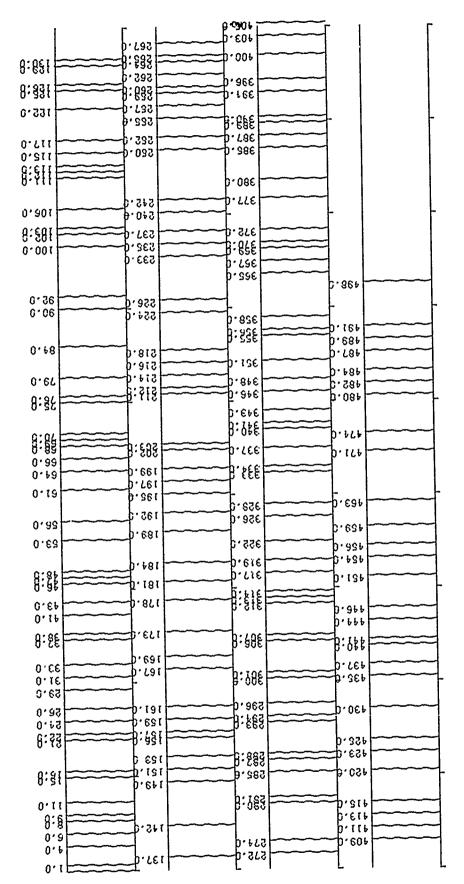
Figure B7. Crack pattern, in feet, for <u>Section A</u> from the May 1975 condition survey.

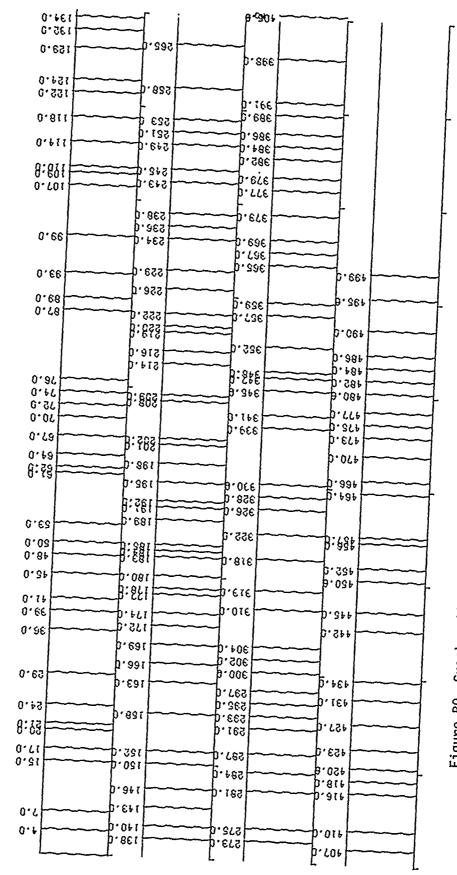
Crack pattern, in feet, for Section B from the May 1975 condition survey . 88 Figure

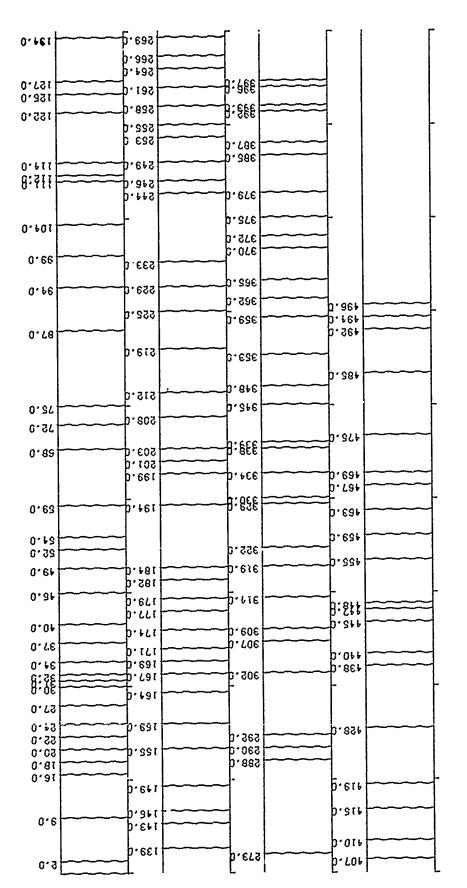
B9. Crack pattern, in feet, for <u>Section C</u> from the May 1975 condition survey. Figure

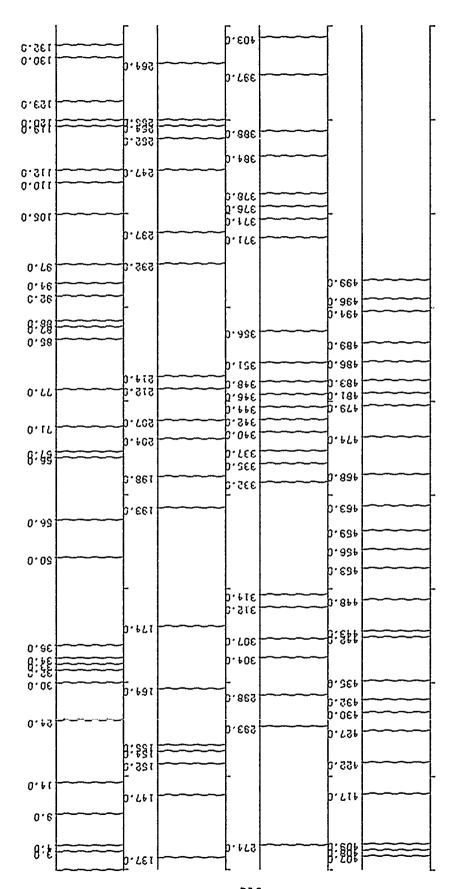
from the May 1975 condition survey Ω Crack pattern, in feet, for Section B10. Figure

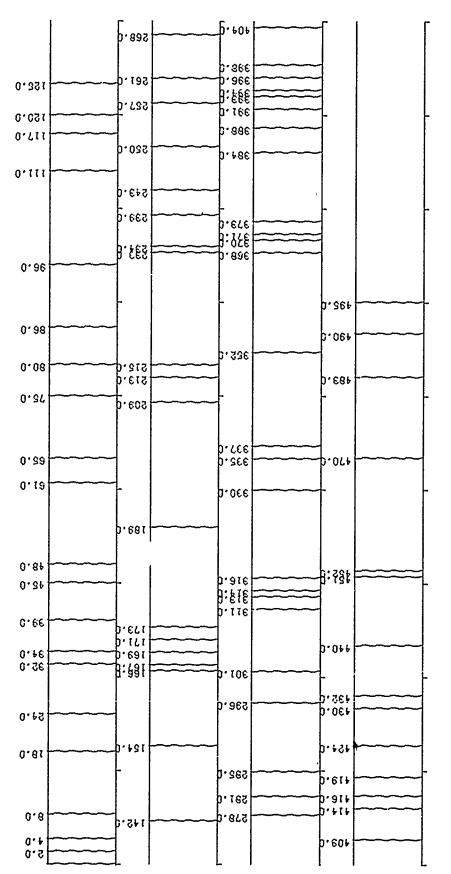
from the May 1975 condition survey. ш Section Crack pattern, in feet, for BII. Figure
